# Accessory Product Information

Europe - November 2018

## RIM HORN WEAR: HOW TO REMOVE SHARP EDGES?

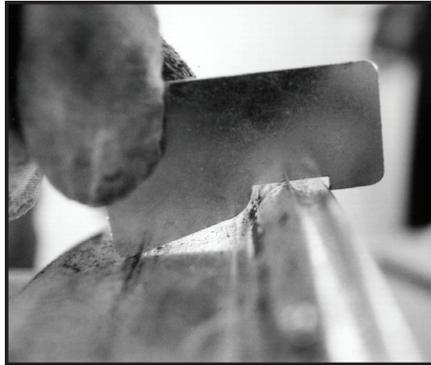
Moderate and even severe rim horn wear is a normal occurrence on both steel and aluminium wheels and on all types of wheels. In many instances, it is non-existent even after several years of service. However, the inspection for wear and sharp edges should be part of ongoing preventative maintenance.

Irregular wear on the surface of the rim flange is caused by bulging and flexing of the tyre side wall which in turn creates sharp edges on the wheel and therefore might damage the tyre.

Simply remove the sharp edges by means of a metal file, sanding machine or grinding machine. Use our manual rim horn wear gauge (P/N GAXGAUGE001) to determine if the rim edge is still serviceable or not.

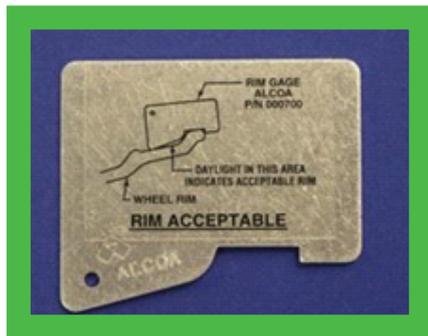
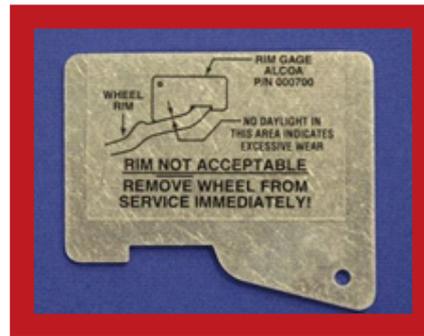
4. Check the rim horn height again with the rim horn wear gauge to make sure there is adequate height remaining to safely support the tyre. If the entire wheel flange is within the limits of the gauge, the wheel may be returned to service. See graphic 13-25 and 13-26.

**Permanently remove** any wheel from service that has inadequate rim flange height - **if you are unable to see any daylight under the gauge area** - (see graphic 13-27) as this can lead to an explosive separation of tyres and wheels!
